A RECENT STUDY OF WATER QUALITY OF DAL LAKE IN SRINAGAR J&K

Ruhail Maqbool Sheikh¹ and Sushmitha Baskar²

Abstract

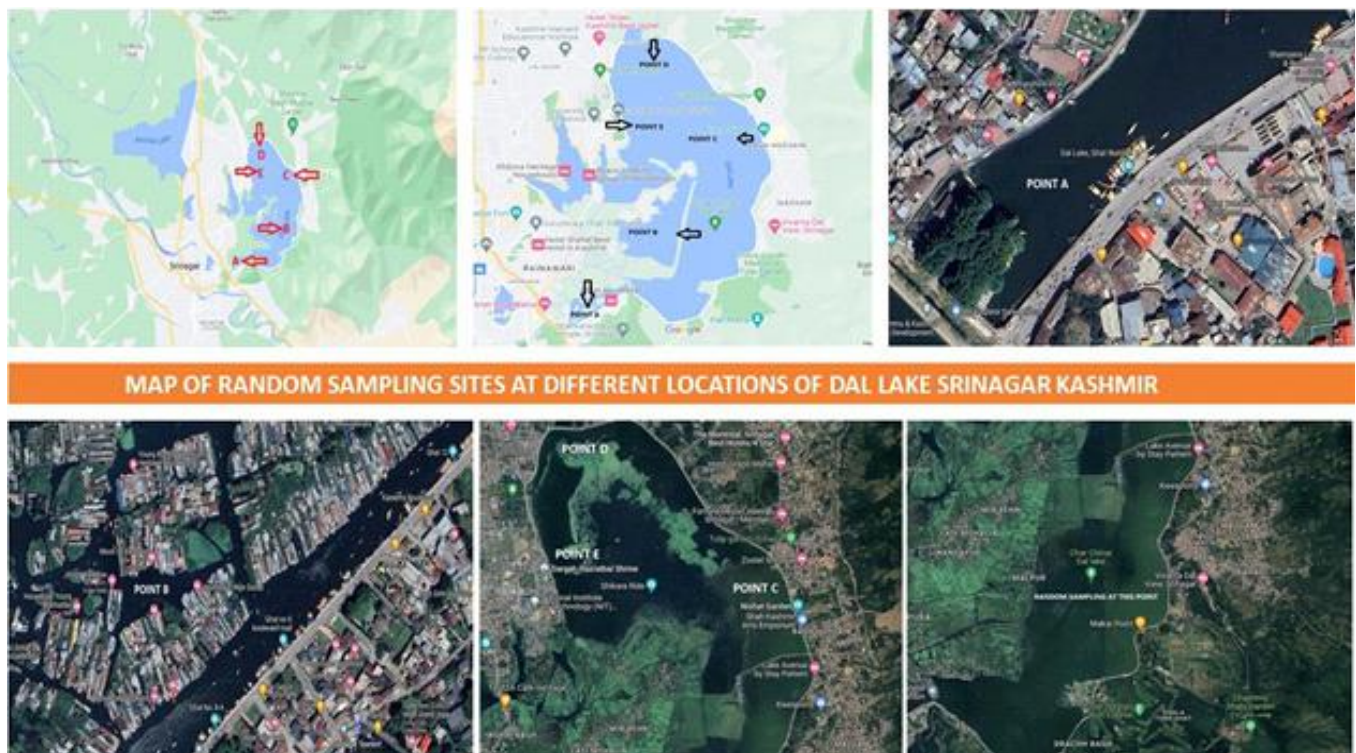
Figure 1: Map of sampling sites at different locations of Dal Lake, Srinagar, Kashmir

S. No	Name of Location and sampling points	Location Code	Latitude	Longitude
1.	Dalgate	A	34.0985	74.8761
2	Nehrupark	B	34.1251	74.8782
3	Charchinar	C	34.1032	74.8667
4	Nigeen	D	34.1182	74.8317
5	Hazratbal	E	34.1289	74.8425

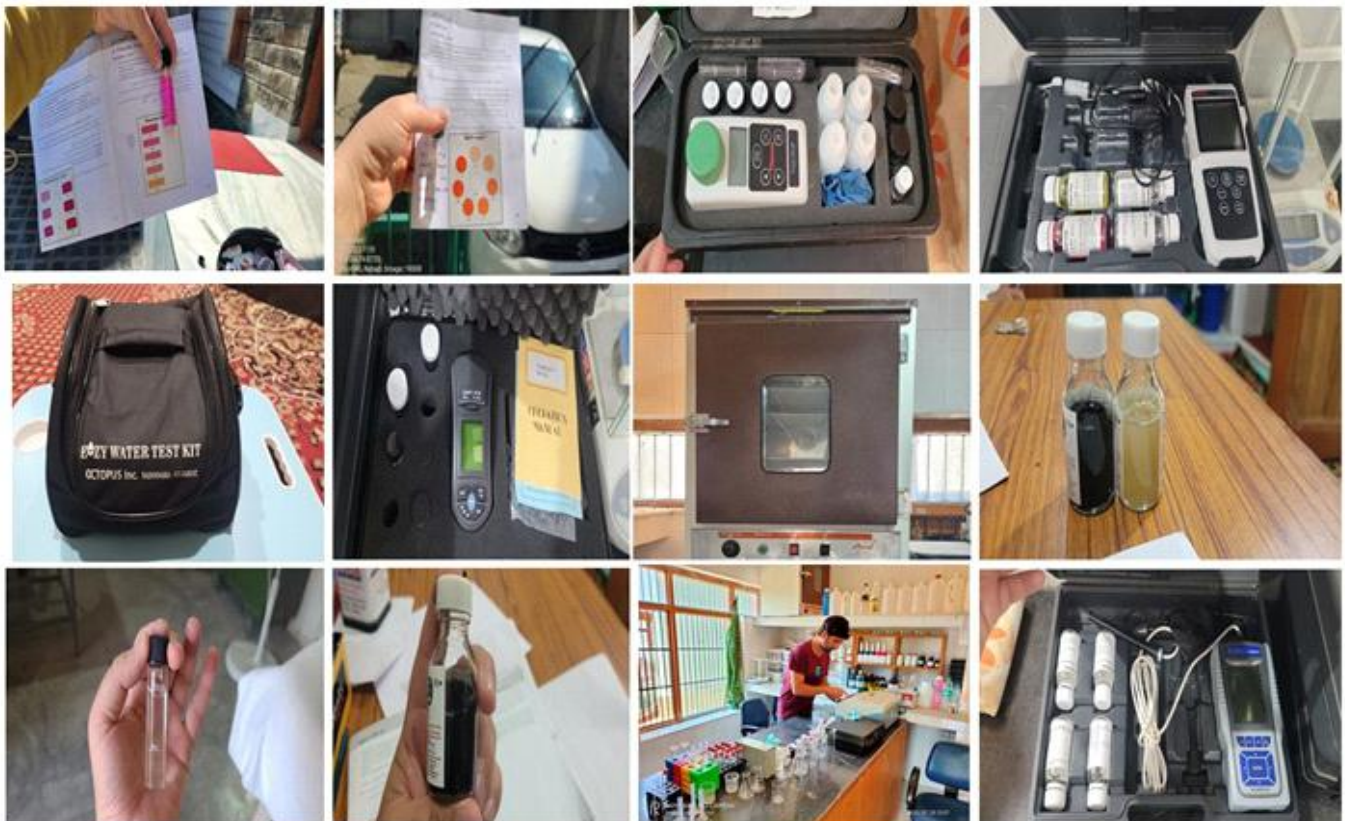
Figure 2: Instruments used, and methods employed.

The samples were collected from April 2024 to July 2024. Standard methods were used to investigate the physicochemical and biological parameters. pH (Digital pH meter Eutech), Turbidity, Total dissolved solid (TDS) was determined by (Digital meter Eutech), Electrical conductivity (EC) (Digital EC meter Eutech). Fluoride, Iron, Nitrate, Sulphate, Chloride, photo spectrometer E. coli by H₂S Vials. Total Alkalinity (TA) as HCO³⁻, Calcium (Ca²⁺), Magnesium (Mg²⁺) Total hardness (TH), chloride (Cl), was estimated by standard titrimetry. Sulphate (SO₄²⁻) by

turbidometry, Nitrate (NO₃²⁻) by UV-VIS spectrophotometer. Standard methods such as APHA (2017) and BIS were used in the analysis (2012). Field Test Kits were utilized for on-the-spot examination, and additional methods included photo spectrometric methods, turbidity and pH were measured using electrometric methods. As a result, the results were obtained using either digital meters or the colour comparison approach. Figure 2, 3 and Table 2 shows the sample collection, various water quality parameters analysed and the methods employed.

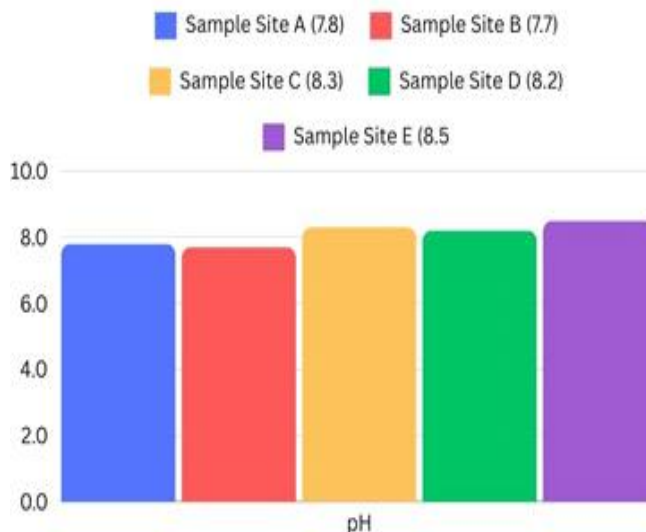
Figure 4: pH of the samples analysed.

According to water quality standards, the pH limits should be 6.5 - 8.5. The pH values for all the samples were above 7.0 at all points (Figure 4). The pH of all the samples was found to be within the BIS range of 6.5 to 8.5. Samples were mostly neutral. The pH from A to E points were normal. The pH limit for drinking water is 6.5 to 8.5. Majority of the samples most of the time showed more than a pH of 8 (Table 1). Similar results were reported by other researchers on the dal lake. Therefore, the pH fluctuated from 7.8 to 8.5. In lakes the occurrence and abundance of components of carbonate system and the pH are determined primarily by current and chemical nature of the substrate. The pH greatly affects the biogeochemistry in aquatic ecosystems, such as growth of fishes and aquatic plants. Because most of their metabolic activities are pH dependant, pH has an impact on aquatic species.

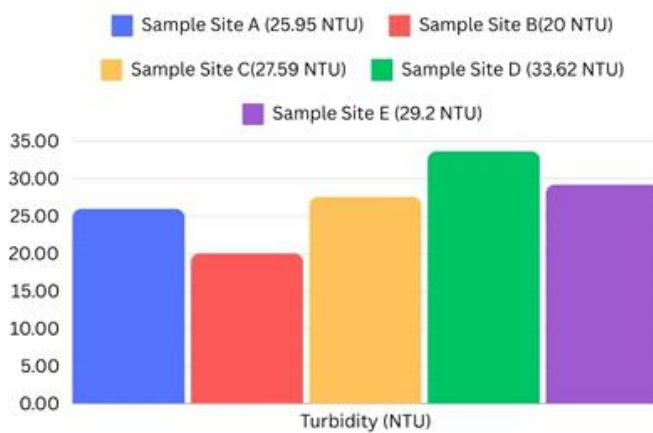
Figure 5: Turbidity of the samples analysed.

The samples were tested for their turbidity, and it was observed to be high and exceeds the permissible limits at almost all points (Figure 5). At point A it was 25.95 NTU and it was above 25 NTU at points C, D, and E but remains above 20 NTU at all points up to point E. At point A the turbidity was noted as (25.95), B (20.0), C (27.59), D (33.62), E (29.20) NTU. Hence, turbidity was above permissible limit at all points (Table 2). The normal range of turbidity as per BIS is that it should not exceed 5NTU. The higher turbidity values indicate pollution and contamination of the waters.

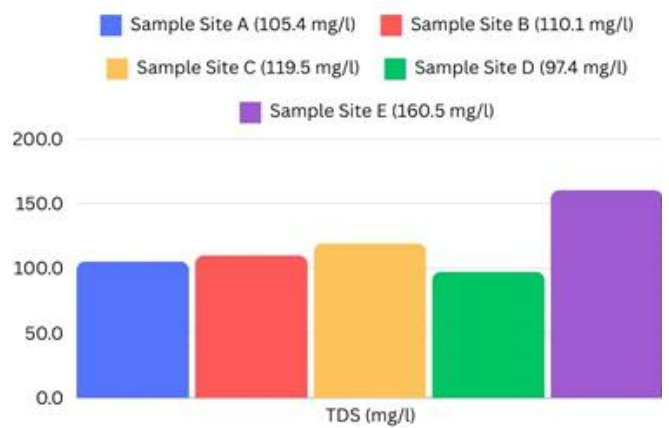
Figure 6: TDS of the samples analysed.

High concentrations of total dissolved solids (TDS) was observed at site E with 160.5 mg/L. This may be due to saprophytic substances due to the decomposition of aquatic plants and animals. The lowest value of TDS was 97.4 mg/L at site D (Figure 6). The rainwaters may have a role in this decrease of TDS concentration during monsoon.

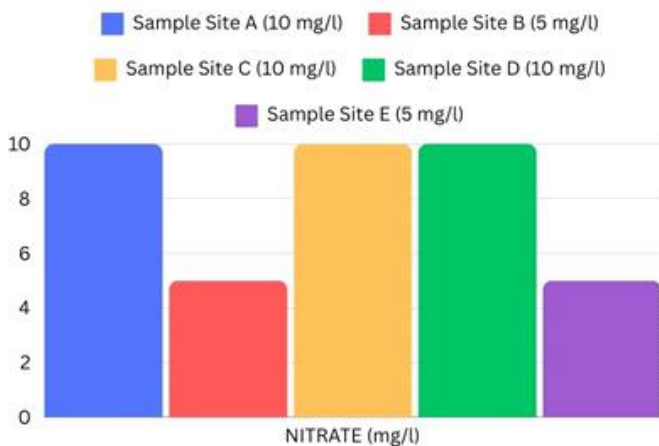
Figure 9: Nitrate content of the samples analysed.

key role in the productivity of an aquatic habitat. Nitrates were present within the permissible limits at all points throughout the period of study. The maximum permissible limit of Nitrate is 40 mg/l.

Almost all the samples had nitrate levels of nearly 05-10 mg/l (Figure 9).

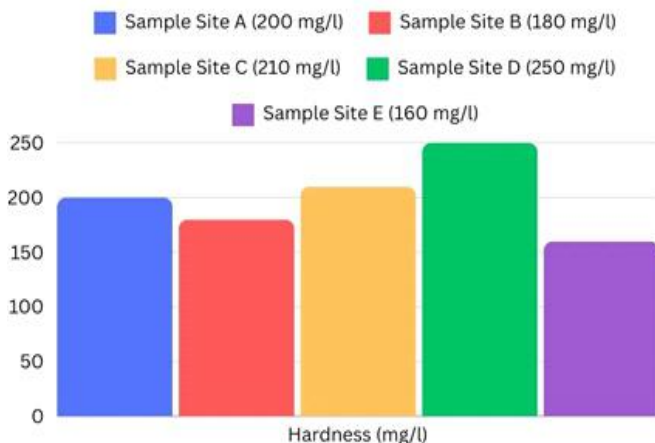
Figure 12: Hardness of the samples analysed.

Total hardness of all the samples was found to be within permissible limit. Average total hardness of most of the samples in the study area was found to be higher than 150mg/l indicating that the water is hardwater. Total hardness in most cases is always higher than 200mg/l which is the permissible limit by BIS as well as WHO standards. At point A Hardness was found (200). B (180), C (210), D (250), E (160) mg/l (Figure 12).

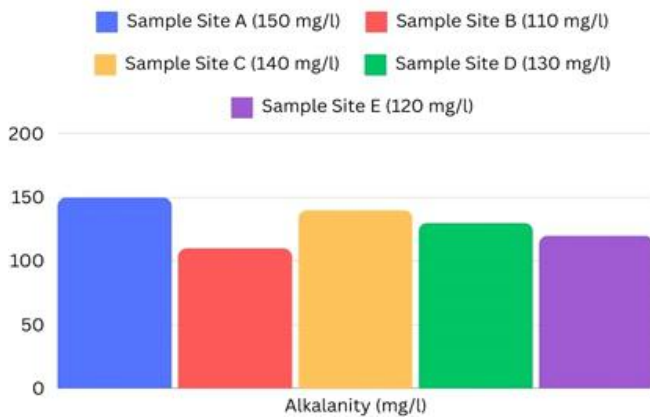
Figure 13: Alkalinity of the samples analysed.

4.11. Alkalinity is the capacity of water to neutralize acid. It is a measure of bicarbonates, carbonates and hydroxides present in water. Alkalinity was found to be within permissible limit. Total alkalinity of all the samples was not found to be higher than permissible

value (200mg/l & 600mg/l) suggested by BIS as well as WHO. At point A Alkalinity was found (150). B (110), C(140),D(130),E(120) mg/l (Figure 13).

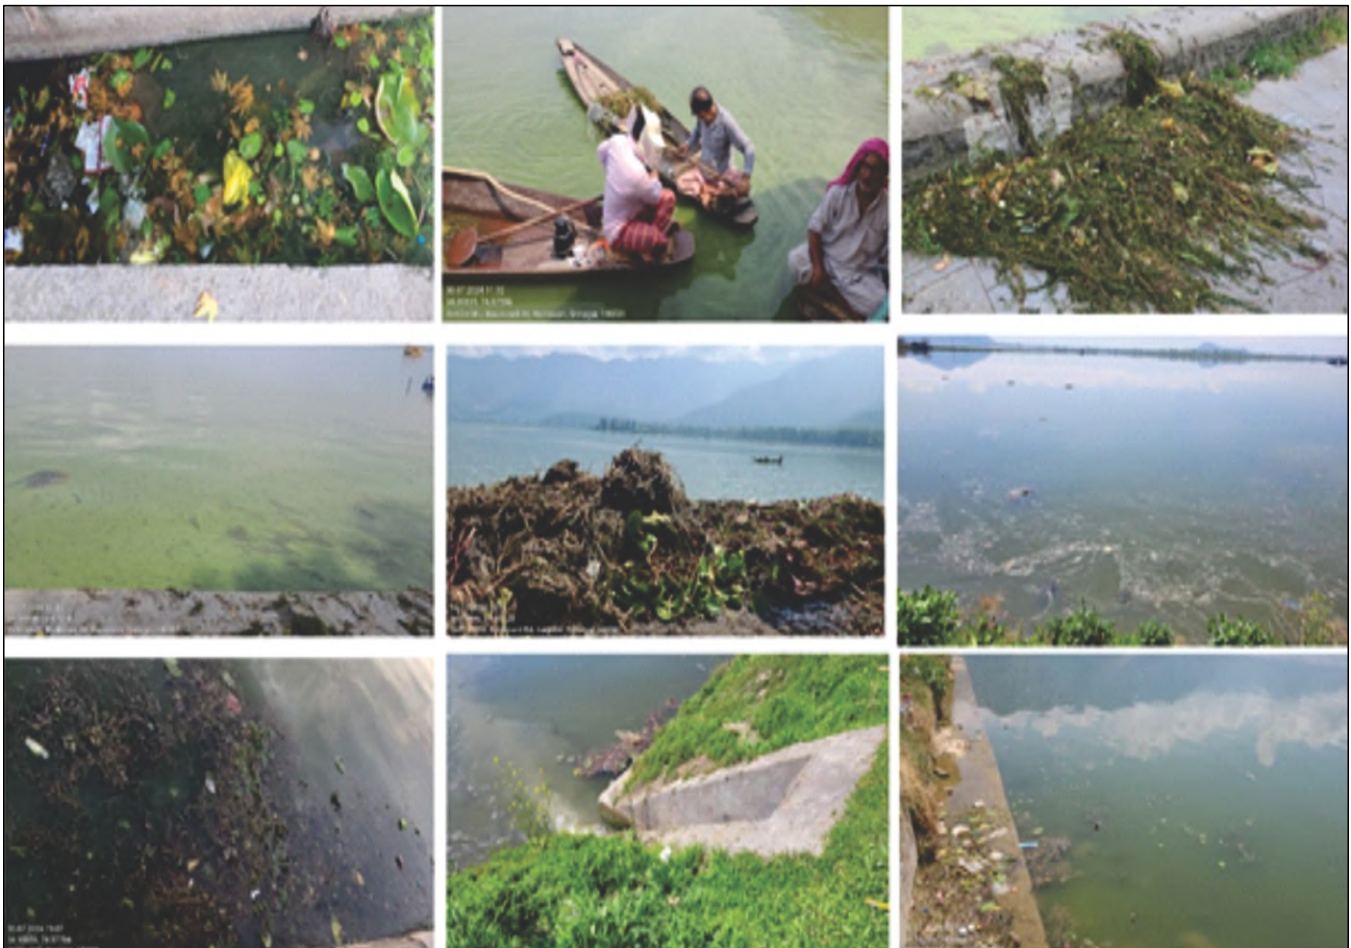
Figure 15: Sampling sites where aquatic weeds, silt & untreated sewage was found.

Overall perception of the current state of Dal Lake: Participants generally expressed concern about the deteriorating state of Dal Lake. Many noted that the water quality has significantly declined due to pollution, encroachments, and unchecked tourist activities. However, some participants were optimistic about recent conservation efforts, though they emphasized that much more needs to be done. Most participants observed a noticeable decline in the lake's health over the past few years. They pointed to increased algae blooms, reduced water clarity, and the shrinking size of the lake as evidence of ongoing environmental degradation. Some noted that the lake has lost much of its former beauty and ecological balance (Figure 15, 16).

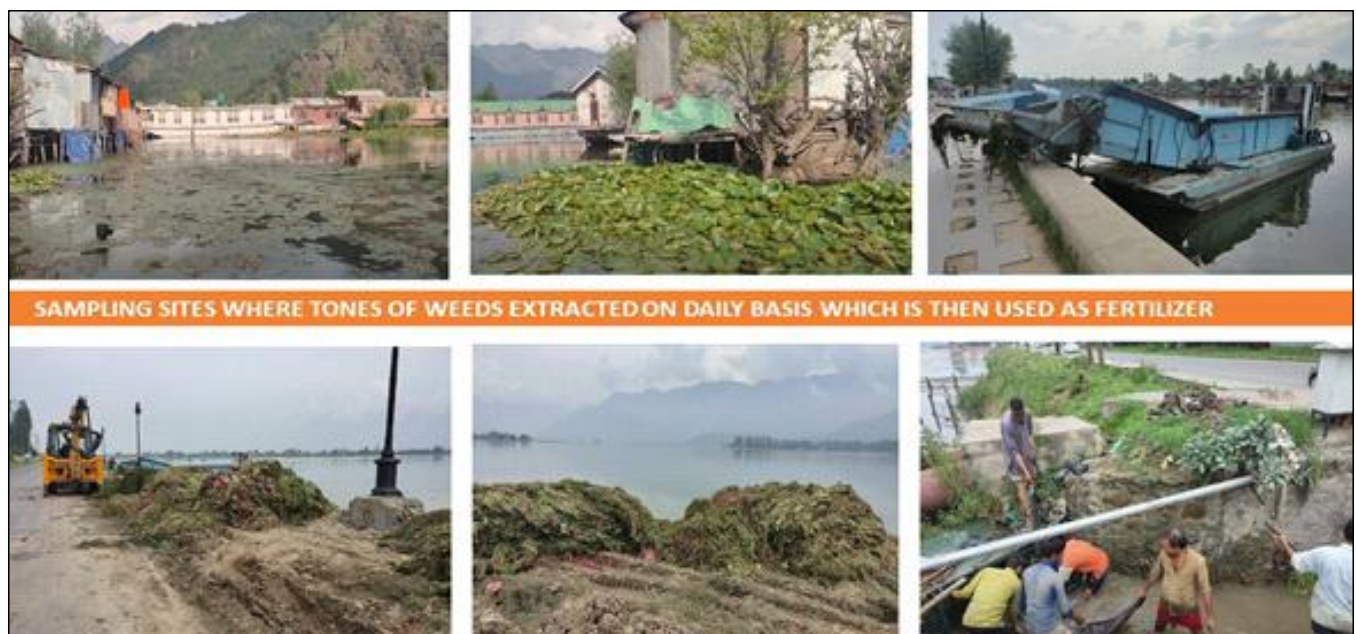
Figure 18: Sampling sites where tones of weeds, silt are extracted and used as biofertilizers.

government, as well as greater collaboration between NGOs and local communities. Some participants reported receiving technical support, training, and resources from NGOs, while others mentioned government schemes aimed at improving waste management. Participants highlighted the need for more financial assistance, better infrastructure for waste management, and stronger enforcement of environmental laws. There was also a call for more inclusive planning processes that involve local communities in decision-making. Further extraction of the weeds and using them as biofertilizers is also being in the lake (Figure 18).
